Eelgrass (*Zostera marina*) and *Caulerpa taxifolia* Survey

591 and 575 Embarcadero, Morro Bay, California

September 15, 2011

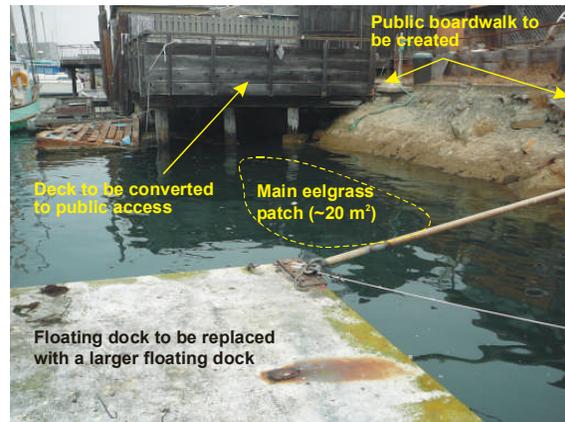
Figure 2. View looking north of deck and dock to be modified and where a portion of the public boardwalk will be installed.

The shore bank along both properties is a cement rock revetment that angles steeply downward from land into Morro Bay (**Figure 2**). The toe of the revetment is at a depth of approximately -9 ft MLLW. The seabed offshore is sand/mudflat.

A single dense patch of eelgrass (approximately 20 m², 215 ft²) was present on the revetment between the existing floating dock and overhanging deck (**Figures 2 and 3**). This was the largest patch in the project area, and was sampled for stem densities and blade lengths (**Table 1**).

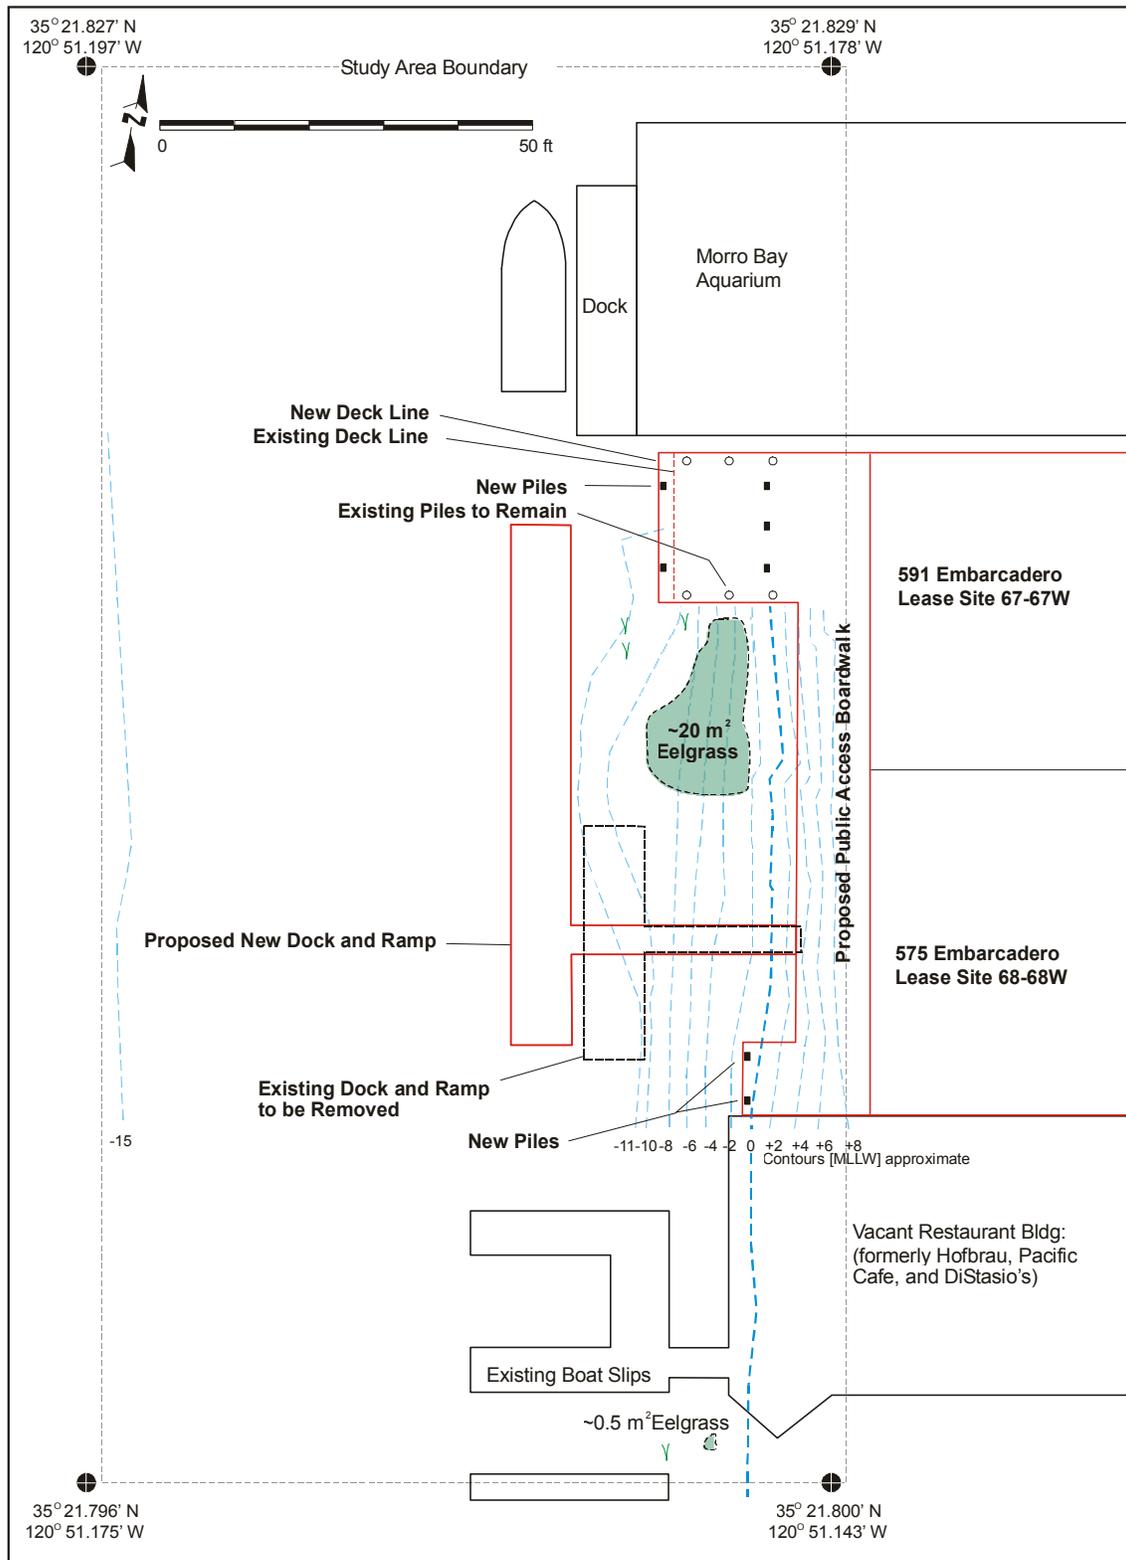
Figure 3. Proposed changes over water at 591 and 575 Embarcadero, Morro Bay, California and results of the eelgrass mapping survey on September 9, 2011.

In addition to this patch, three single plants totaling less than 0.25 m² (2.7 ft²) in area cover were present near the 'main' patch (**Figure 3**). Another patch of eelgrass (approximately 0.5 m², 5.4 ft²) with a single plant nearby were both south and well away from the proposed construction. No other eelgrass was observed.

Effects from the New Dock: No eelgrass or habitat for eelgrass should be affected from the proposed new dock. The new dock is planned to be positioned so that it will not occur directly over the largest patch of eelgrass found in the project area. Also, its position will be over sand/mudflat where eelgrass has not been found.
